ERDC/CHL TR-04-8

## **Toussaint River, Ohio, Ordnance Migration Study**

August 2004

Final report

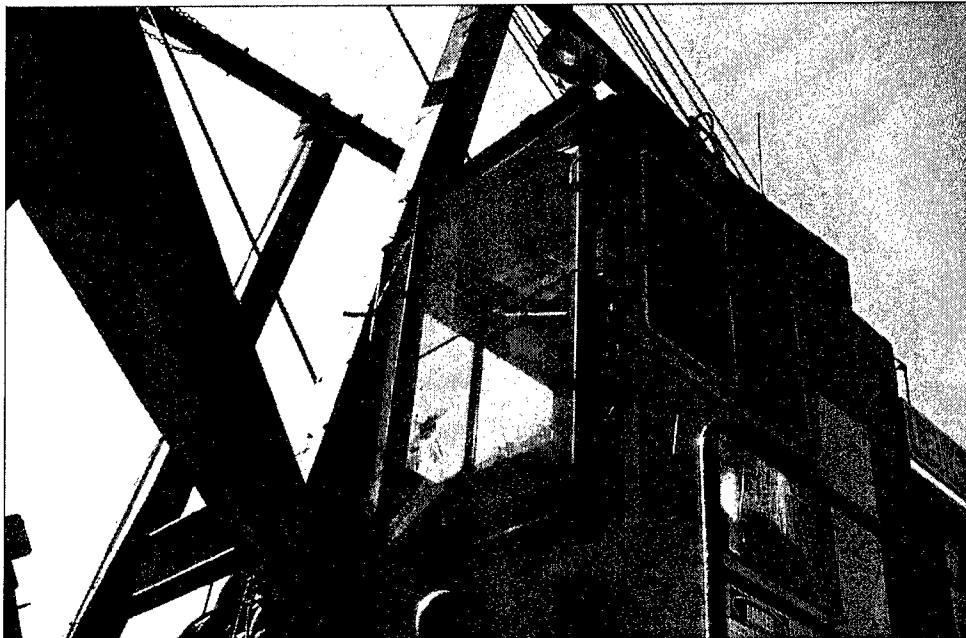
Figure 7. Crane operator's protective barrier

The contract specifications required that the crane operator be protected by protective barriers possessing structural properties equivalent to 1.0-in.-thick steel plate protection barrier (as compared to the 0.25-in.-thick plate required in 1995)(Figure 7), as well as the crew on the spud barge (Figure 8) and the scow release operator. The scow operator was to be protected during dumping operations, from any potential exploding ordnance. The protection provided was similar to the crane operator's protection and was located at the scow release-mechanism station (Figure 9). A "Safety Zone" of 1,250 ft between the disposal scow and any other vessel was in effect during disposal operations. No personnel were allowed on the scow during transport operations, and once over the disposal area, a single workman was transported to the scow to accomplish the unloading procedure. That workman was required to be behind the protection equipment prior to opening any of the scow doors.

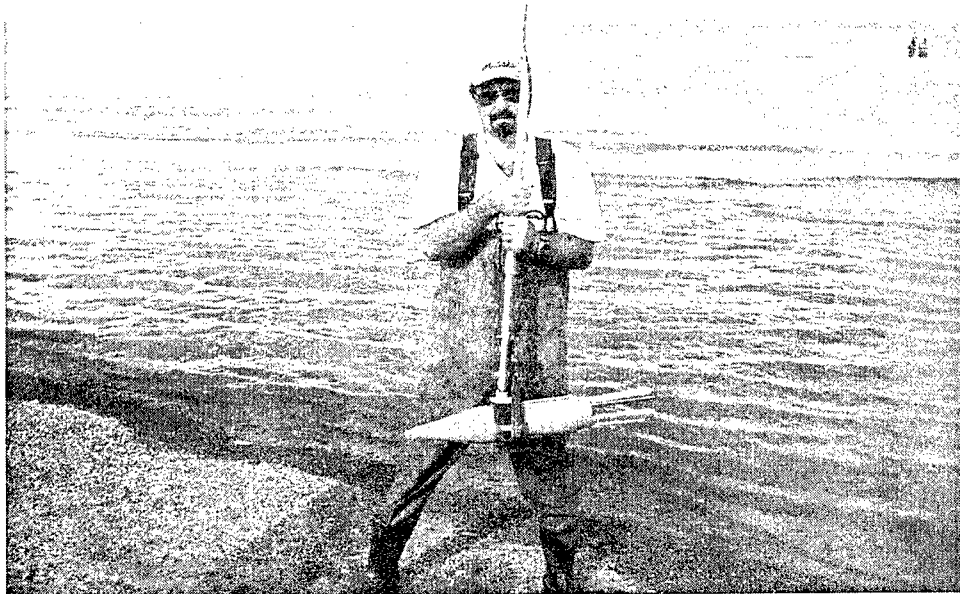
SO was placed on the lake bed using an SO deployment device (Figure 18). The device was needed to assure that the desired deployment orientation of the SO could be achieved, and to establish a deployment location when visibility was

Figure 18. SO deployment device. Note the gentle bathymetry slope of study site illustrated by depth of water that the two people in upper right-hand corner are standing in and the waves shoaling on the first sand bar offshore

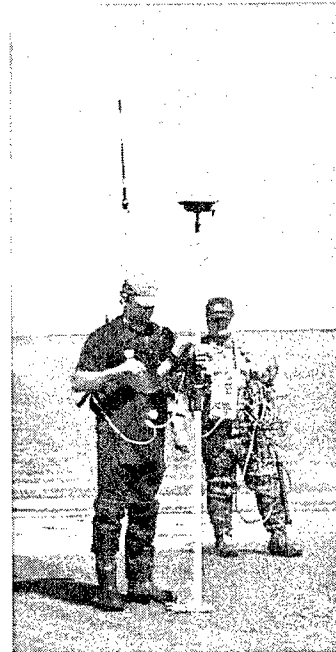
Figure 19. The Trimble Model 4700 RTK Rover positioning 60-mm SO

The shallow-water deployment consisted of wading out into the water while practicing anomaly avoidance and placing (and positioning with a mobile-pack RTK DGPS) the SO in locations determined to be anomaly-free. Placement of the SO in deep water involved the use of a shallow-draft boat. The deployment process consisted of establishing safe anchoring locations (practicing anomaly-avoidance), and placing (and positioning with RTK DGPS) the SO in anomaly-free locations.
